MARINE INVESTIGATION REPORT
M00L0043

FALL OVERBOARD

FROM THE PASSENGER VESSEL *MISS GATINEAU*
OTTAWA RIVER
12 MAY 2000

Report Number M00L0043

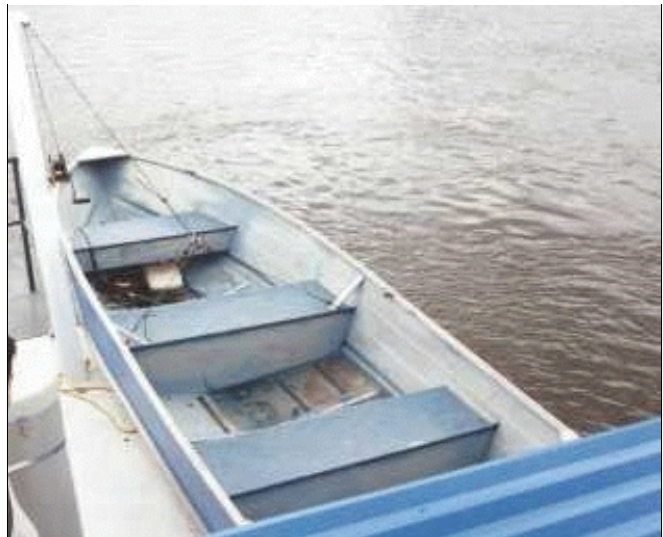
Figure 2 - Lifeboat of the *Miss Gatineau*

In 1992 Transport Canada Marine Safety (TCMS) advised the original owner that the lifeboat on board was required to be equipped with a motor (see Figure 2). In response, the vessel's owner requested and was granted an exemption from the Transport Canada Board of Steamship Inspection (BSI) from the requirement to carry a motorized rescue boat capable of towing liferafts, citing the oar-equipped skiff on board as an alternative. At the time of the occurrence, the new owner (son of the original owner) was under the impression that TCMS would not allow him to equip the lifeboat with an outboard motor.

From the time the victim fell overboard until the lifeboat from the *Miss Gatineau* was in the water, the distance between the victim and the *Miss Gatineau* increased rapidly. During the three minutes taken to stop the vessel and launch the lifeboat, the victim would have drifted a minimum of 200 m downstream from the *Miss Gatineau*. It was therefore imperative that the lifeboat proceed as rapidly as possible downstream to locate the victim. The lifeboat, however, was not equipped with a motor and could only make good two to three knots through the water.

In 1993 the then owner of the *Miss Gatineau* had applied to the BSI for an exemption from the requirement to carry a motorized boat on board. The requirement for a motorized boat was primarily intended to facilitate the marshalling of liferafts, and the rescuing of persons in distress.⁸ Since the *Miss Gatineau* was operating in sheltered waters a short distance from shore, the BSI granted the exemption. The BSI considered an aluminium skiff, propelled with oars, (as carried on board as a lifeboat at the time of the occurrence) to be a suitable alternative.

Consequently, the *Miss Gatineau* was not equipped with a motorized boat which would have allowed the crew to rapidly proceed downstream in the strong current to conduct a systematic search for the victim.

A TSB Marine Safety Advisory (MSA 10/00) was sent to TCMS describing the importance of having means available to quickly locate and recover passengers or crew members who fall overboard. The MSA suggested TCMS consider measures to ensure that excursion boats (such as the *Miss Gatineau* and other similar passenger vessels) have adequate equipment on board, and have the capability to locate and recover expediently persons who fall overboard, under all of the environmental conditions the vessel might encounter in normal service.

In its response, TCMS indicated that amendments to the *Ship Station (Radio) Regulations, 1999*, will require all passenger vessels to have reliable means of communicating with the shore. Additionally, TCMS will be carrying out an overall review of standards and requirements for lifesaving equipment, including lifeboat requirements; there is a possibility of requiring searchlights on passenger vessels similar to the *Miss Gatineau*.
